Warranty Multi-Point Vehicle Inspection

Date Monday, May 27, 2024

Vehicle Make & Model Bentley Mulsanne

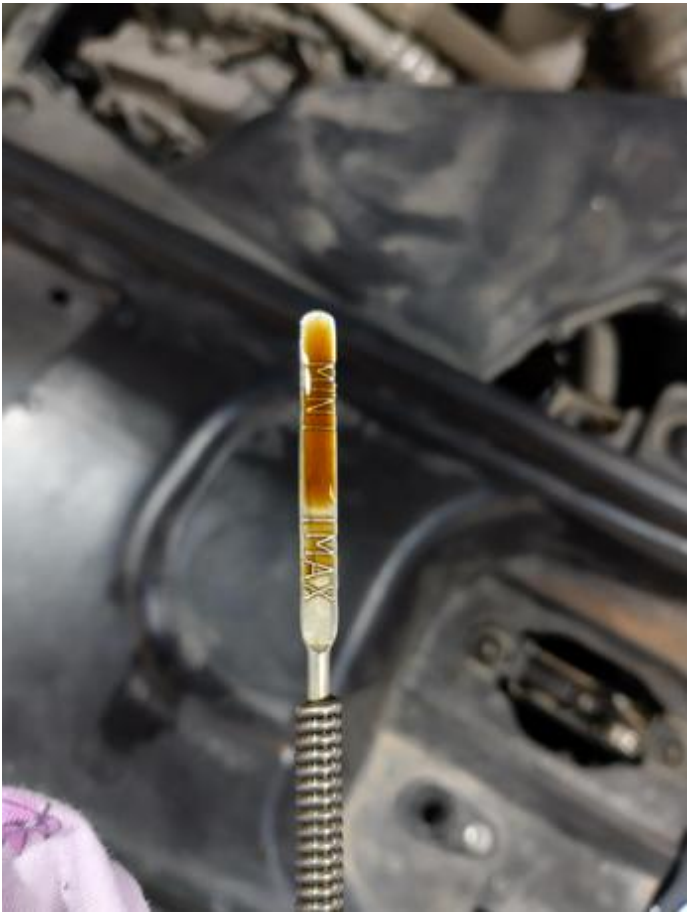
Engine Oil Condition & Service Sticker
(Max 4 Photos)

Checked and OKAY	May require attention SOON	Requires IMMEDIATE attention	%	RESET	N/A
Remaining Engine Oil Life	✓			80

Engine
Engine drive belt
Engine air filter
Drive belt tensioner and idle pulleys
No service sticker found. Recommended to do service.
Cabin air filter
Transmission oil and filter
Rear differential seal
Rear differential oil

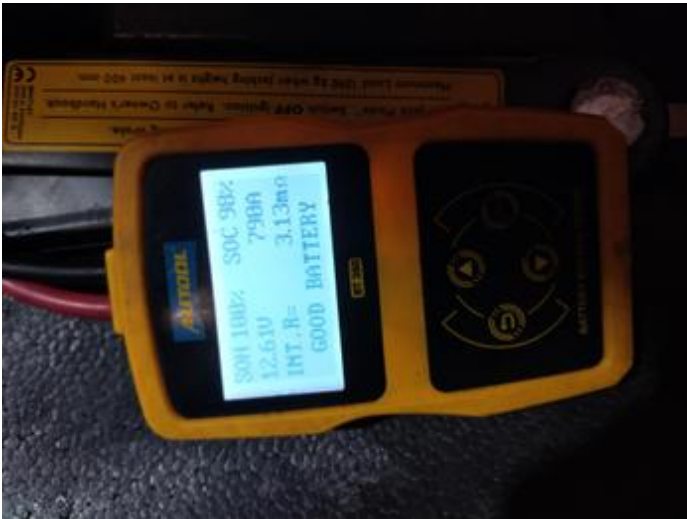
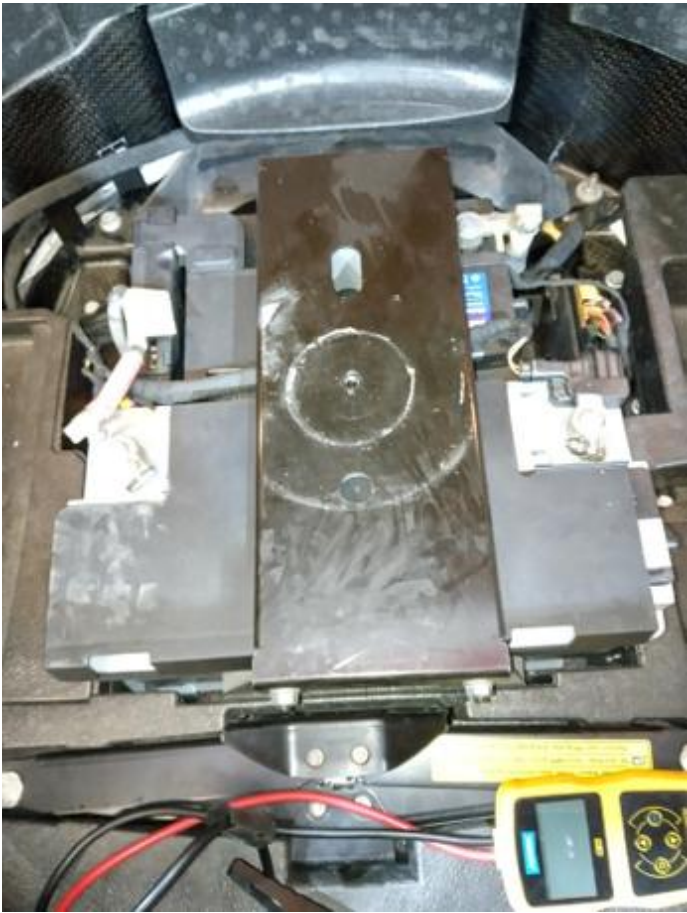
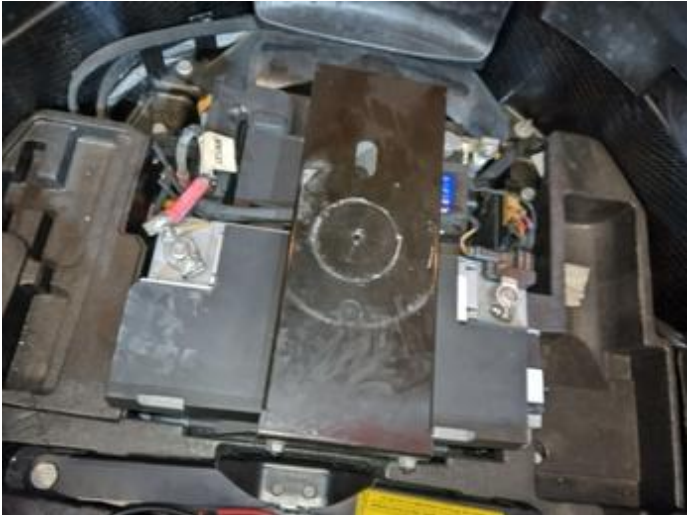
**Battery Test Report & Battery
Terminals (Max 4 Photos)**

Condition	Checked and OKAY
Cables & Connectors	Checked and OKAY

Battery condition is fine

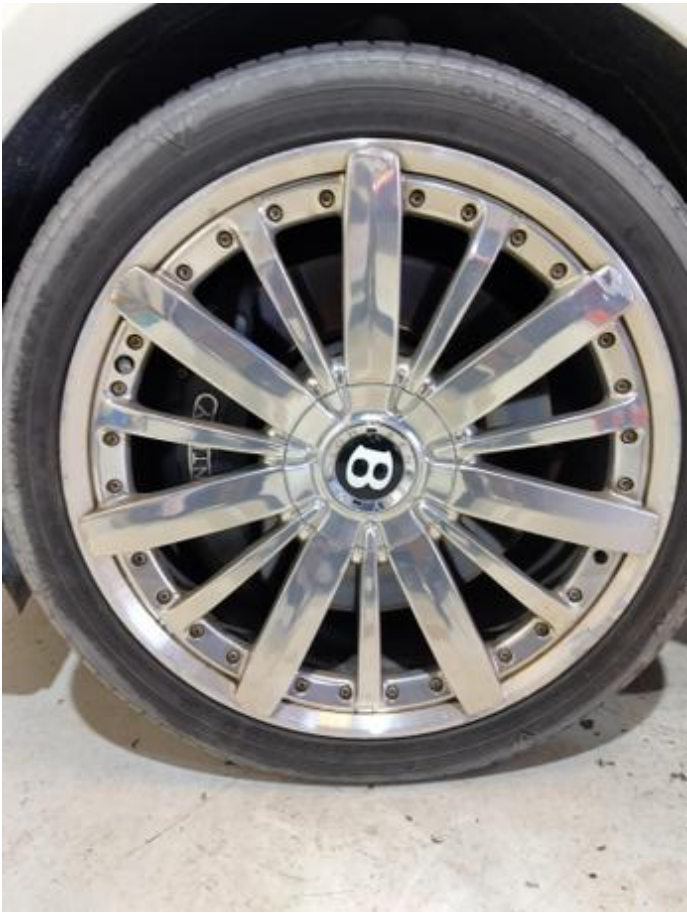
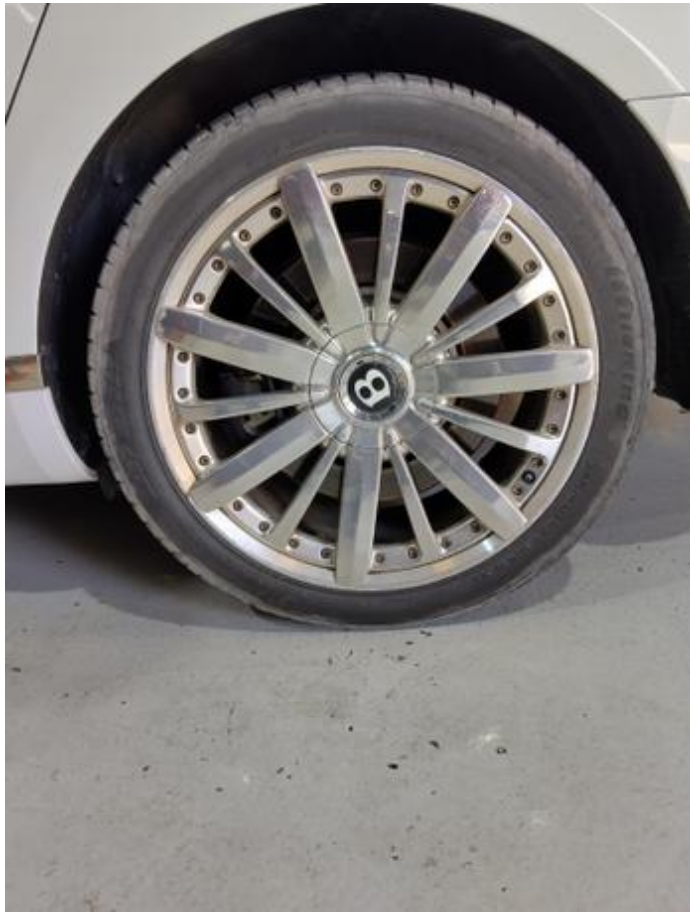
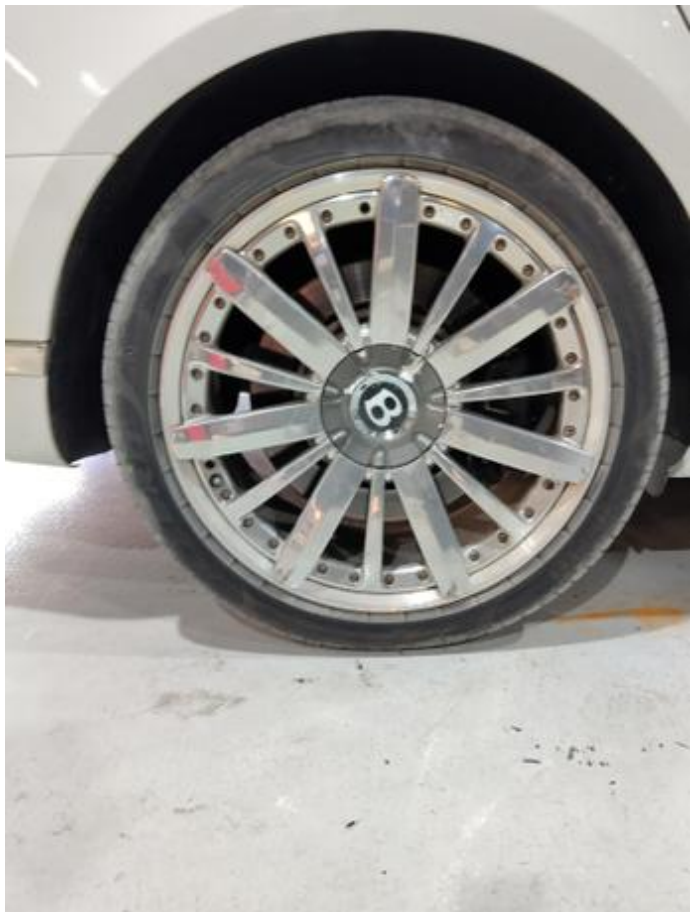
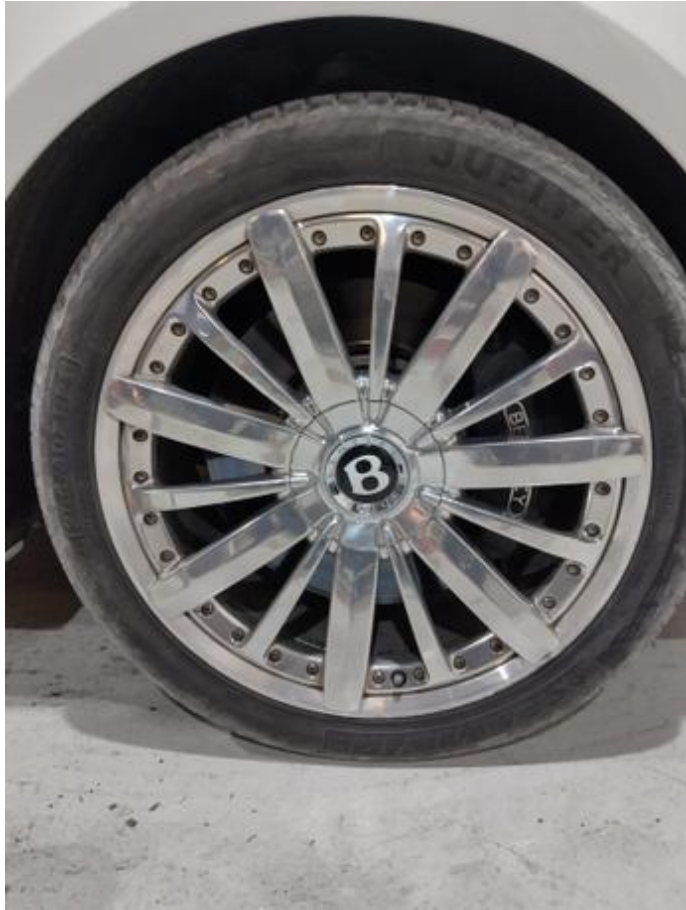
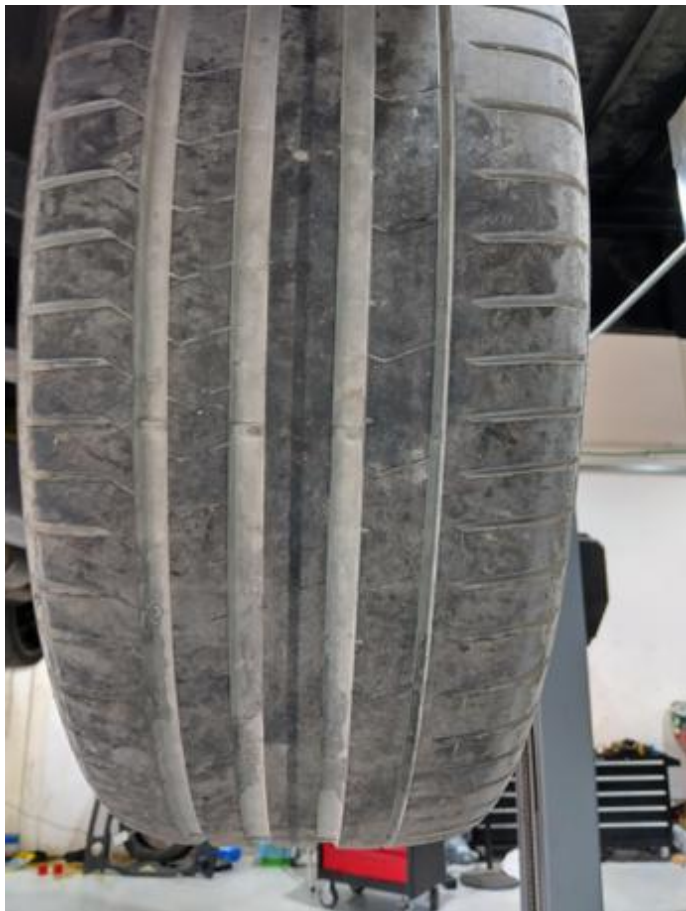
Tyre & Wheel Damages (Max 8 Photos)

Rims has scratches need to replace

Rear right rim is bend

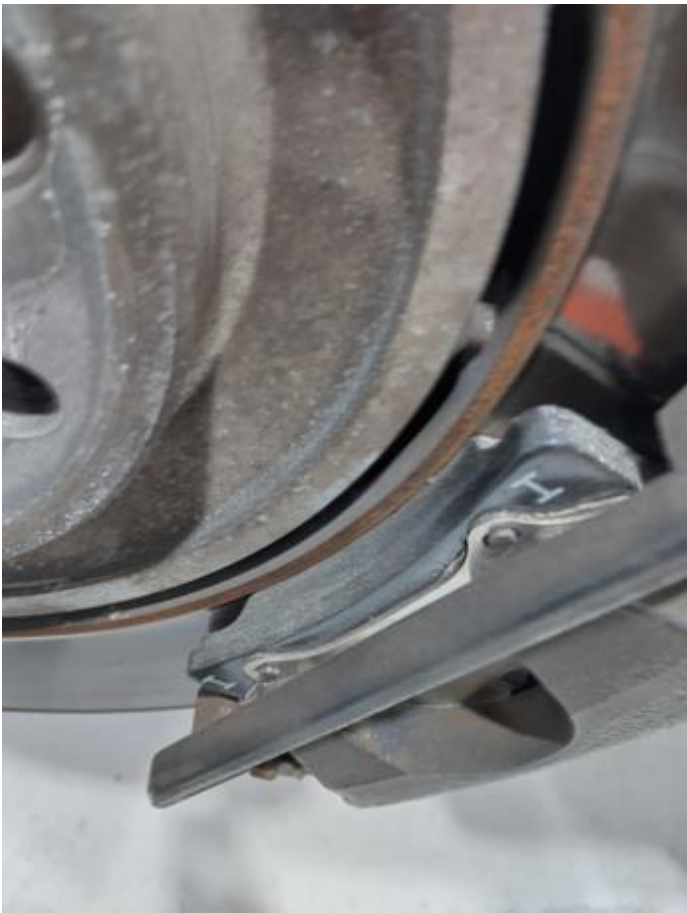
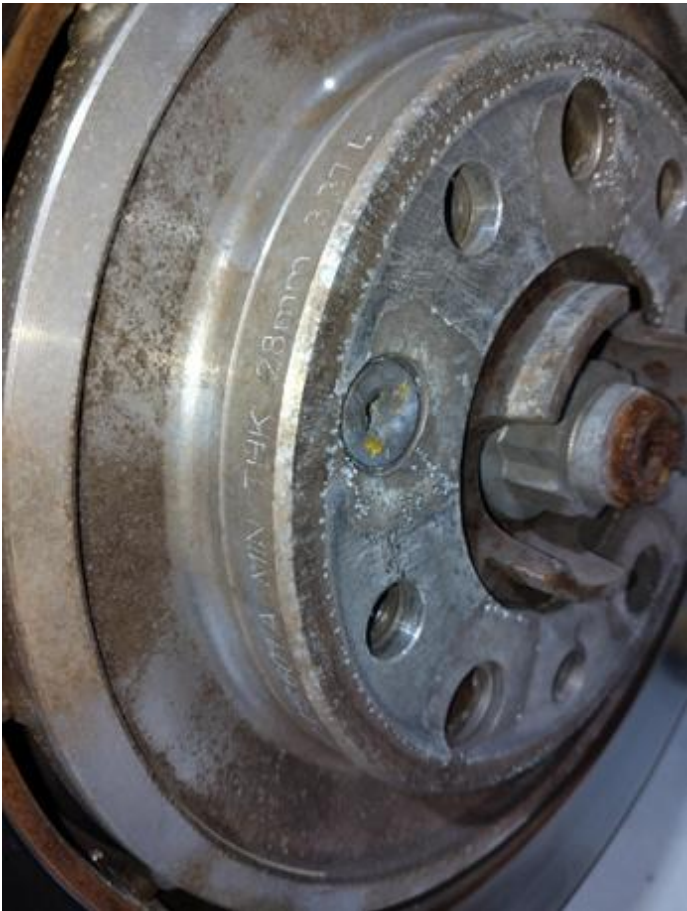
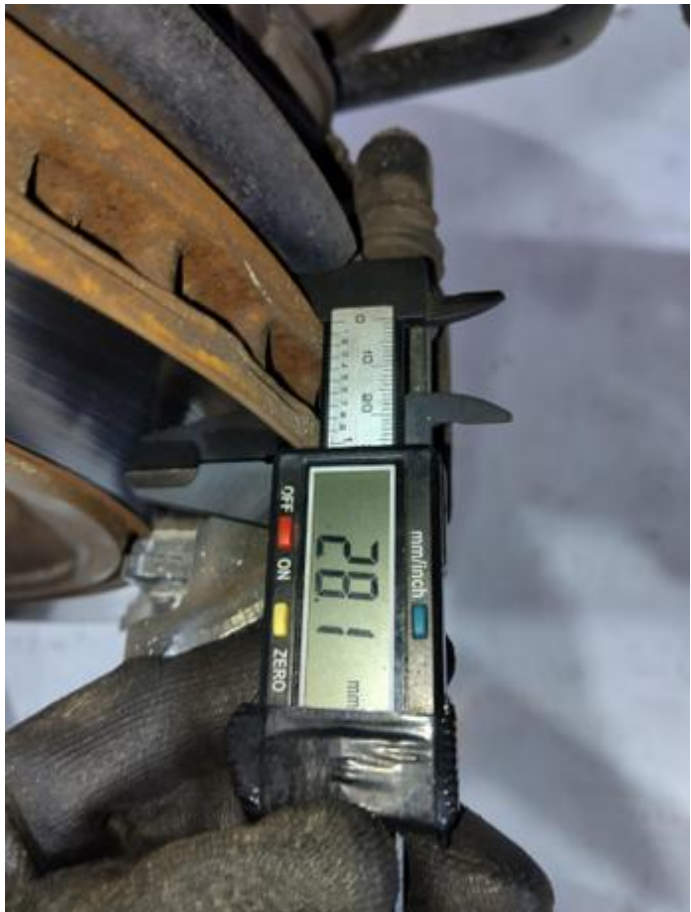
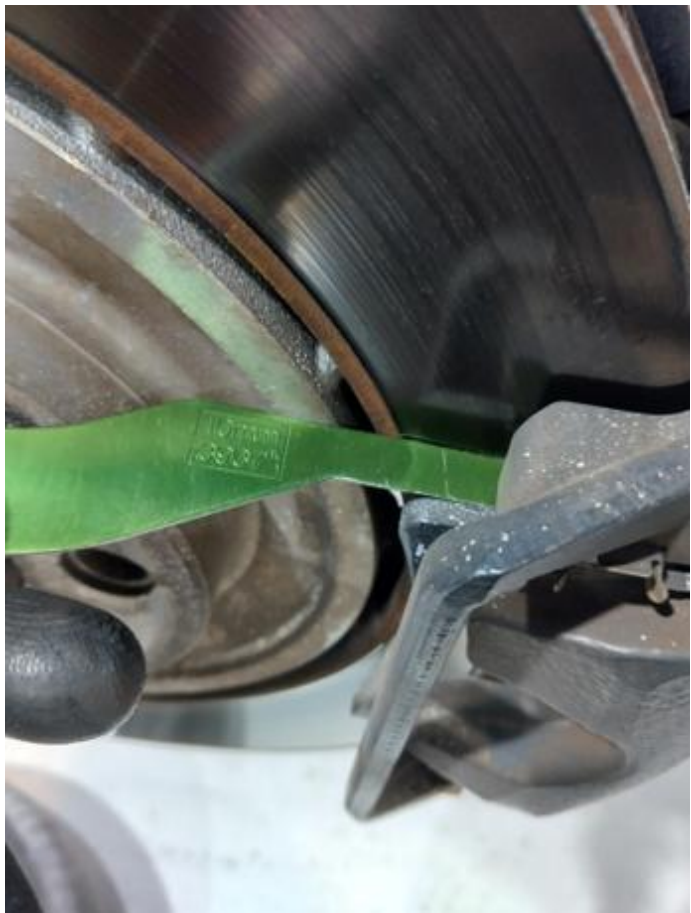
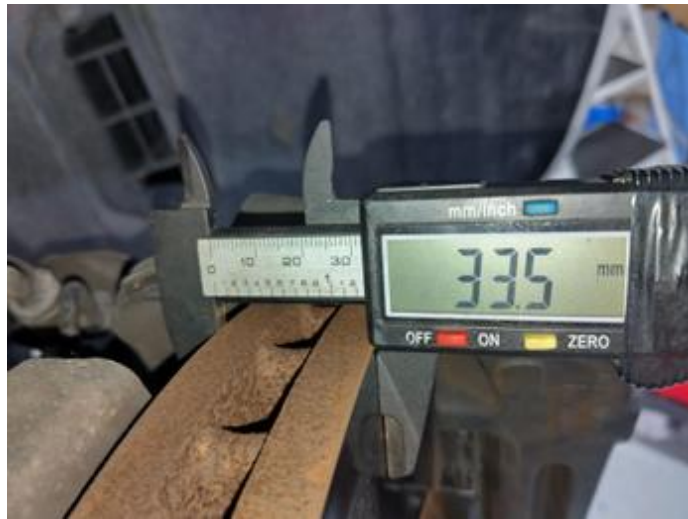
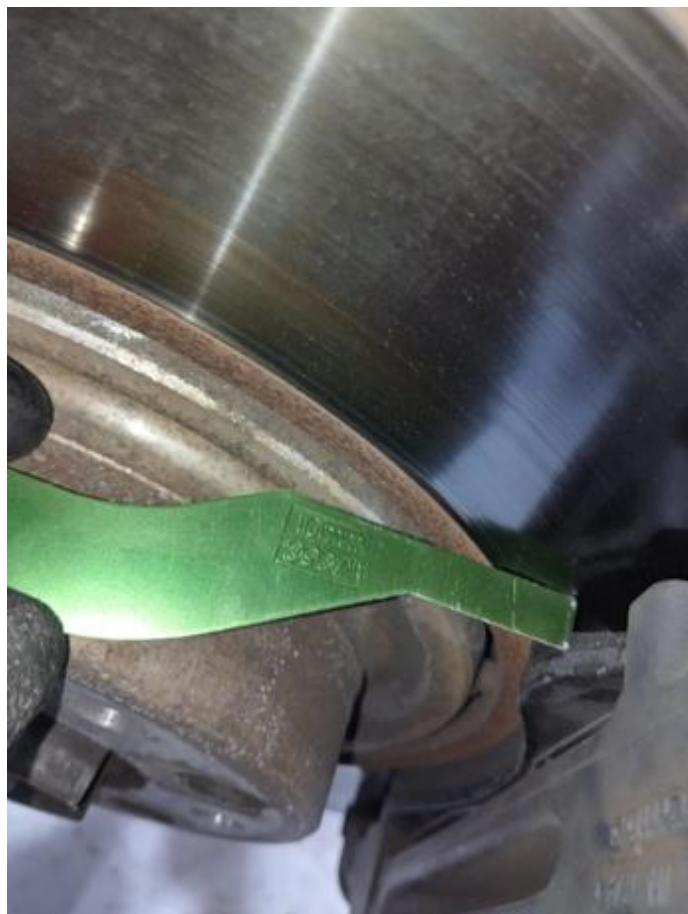
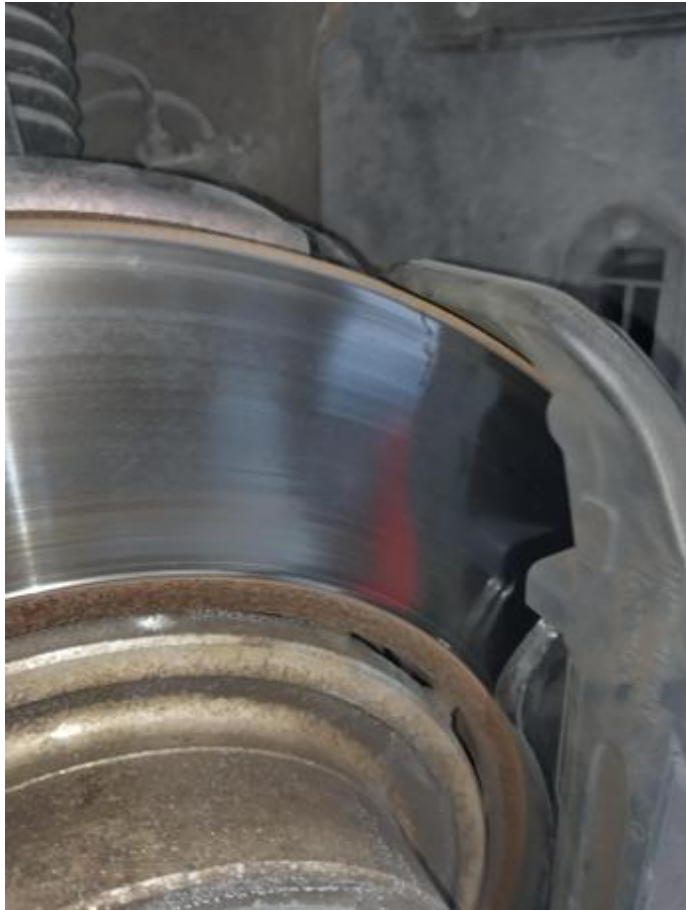
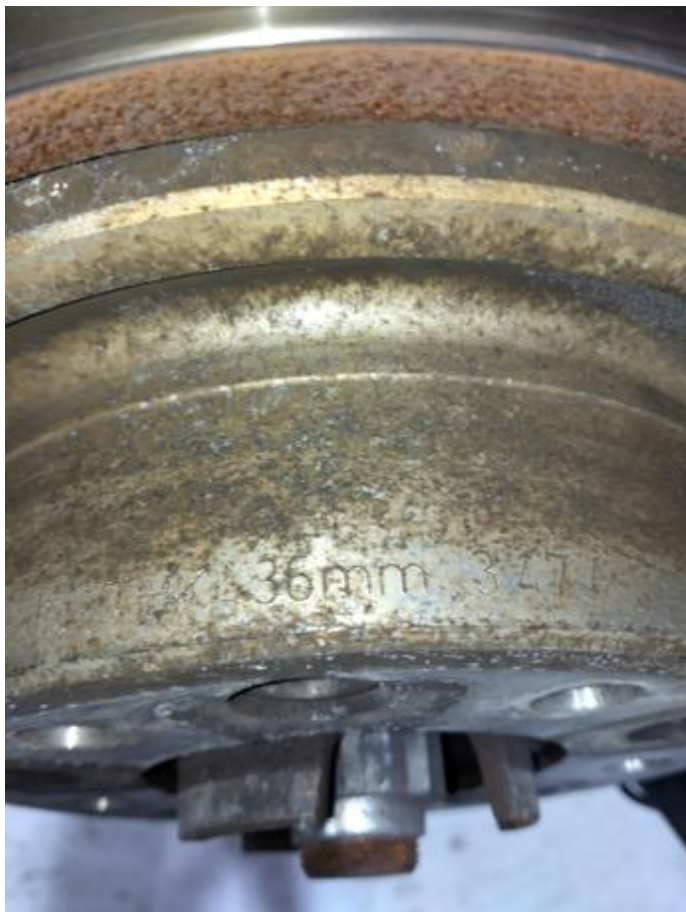
Front & Rear Brake Pad + Disc
Condition (Max 8 Photos)

Minimum Thickness	Actual Thickness	Uneven Surface
Left Front Brake Pad	4mm	10mm	
Left Front Brake Disc	36mm	33.8mm	
Right Front Brake Pad	4mm	10mm	
Right Front Brake Disc	36mm	33.8mm

Minimum Thickness	Actual Thickness	Uneven Surface
Left Rear Brake Pad	4mm	8mm	
Left Rear Brake Disc	28mm	28.5mm	
Right Rear Brake Pad	4mm	8mm	
Right Rear Brake Disc	28mm	28.5mm

Front brake discs is below minimum thickness - need to replace

Rear brake discs is approaching minimum thickness

Brake pads are new

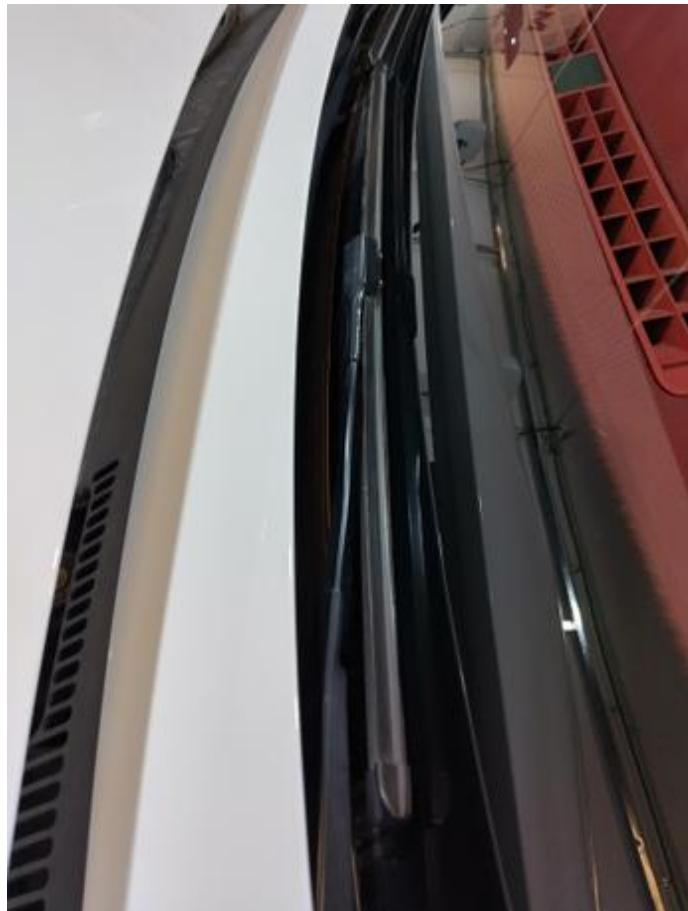
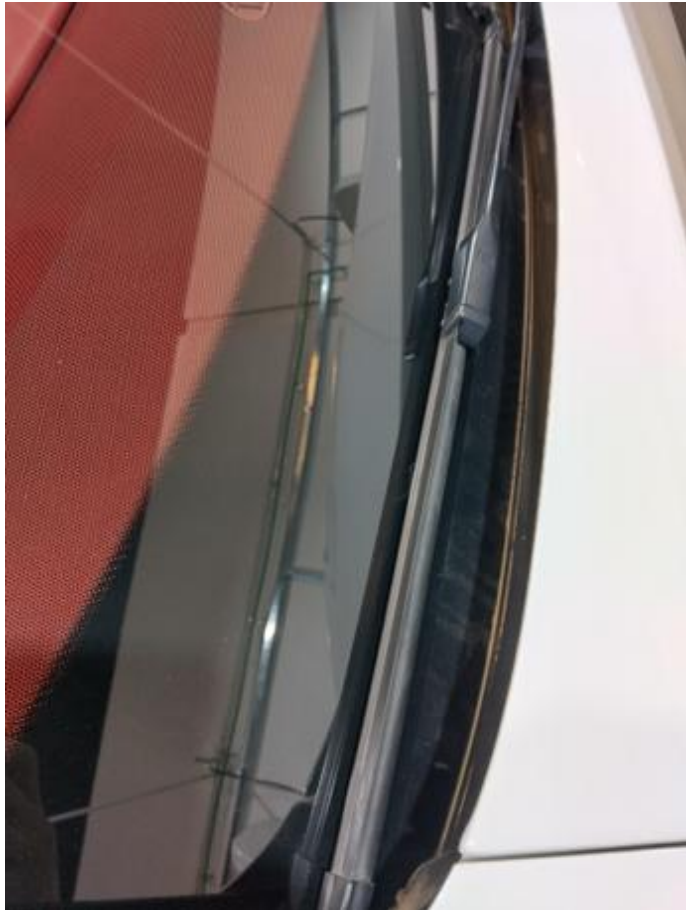
Wiper Blade Condition & Windshield Chips/Cracks (Max 4 Photos)

Wiper blade condition is fine

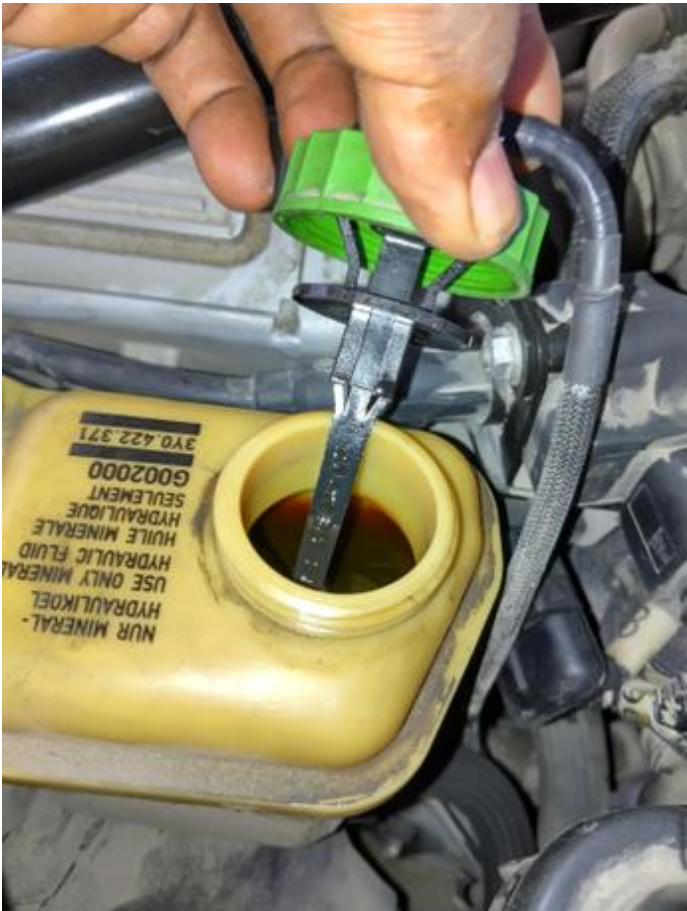
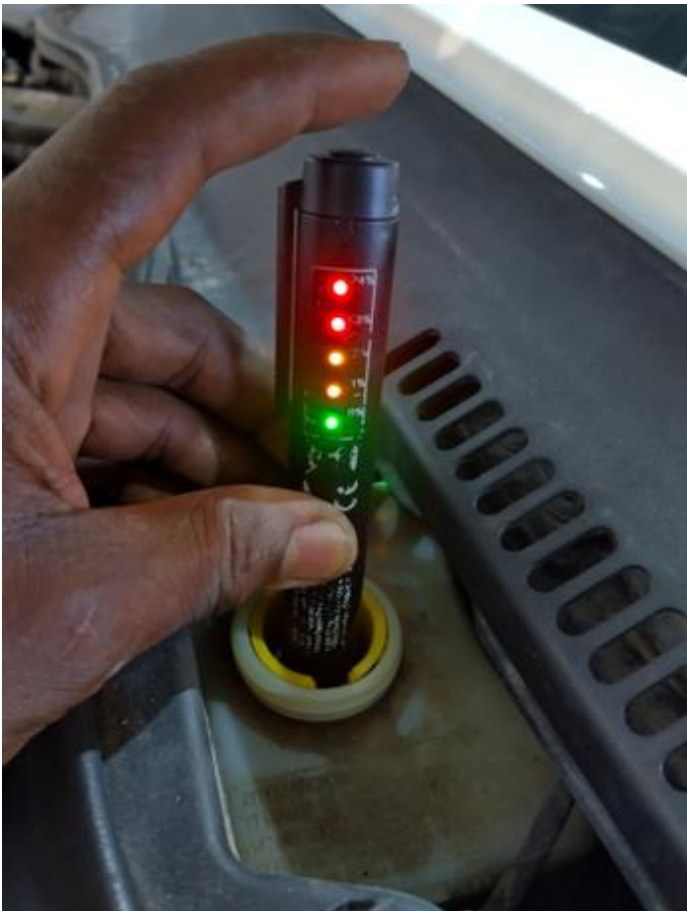
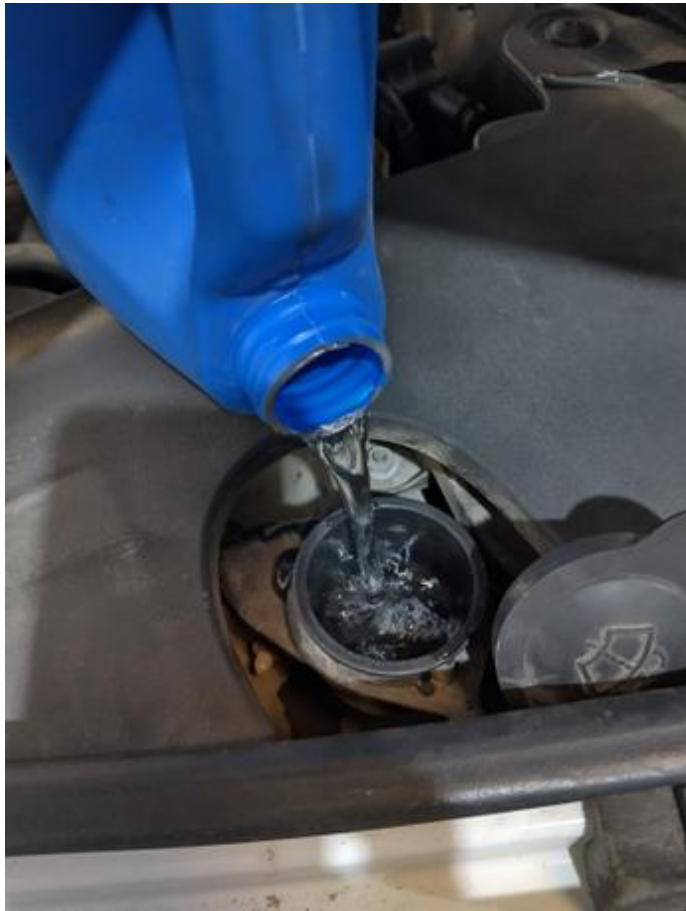
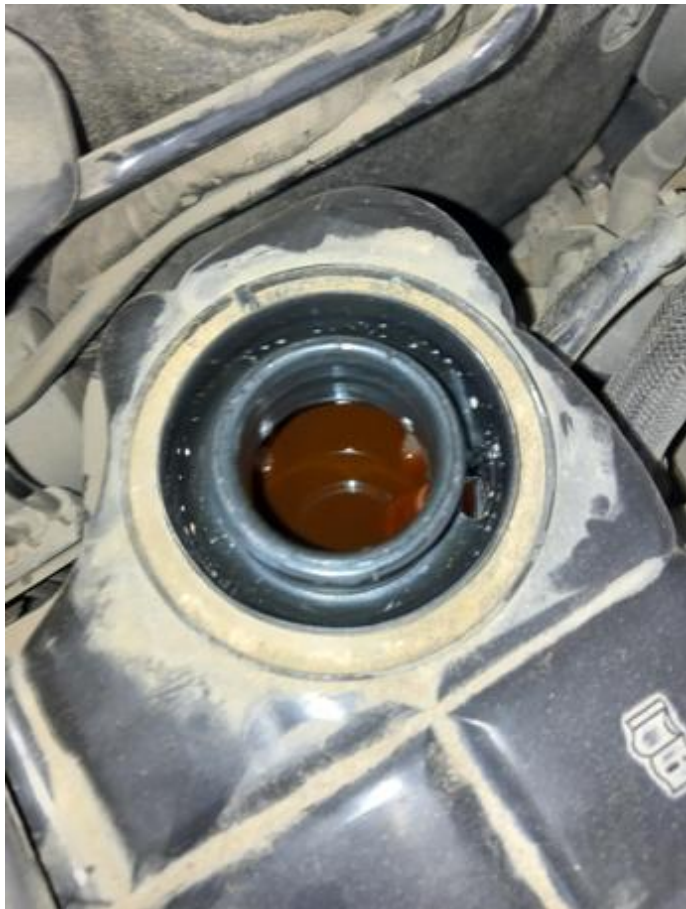
Fluid Level Photos & Condition (Max 4 Photos)

Engine Oil	Okay
Brake Fluid Reservoir	Requires IMMEDIATE Attention
Transmission (if equipped w/dipstick)	Requires IMMEDIATE Attention
Coolant Reservoir	Okay
Power Steering	Requires IMMEDIATE Attention
Windshield Washer	Topped Up

Transmission oil service is required

Power steering oil is required

Rear differential oil need to change

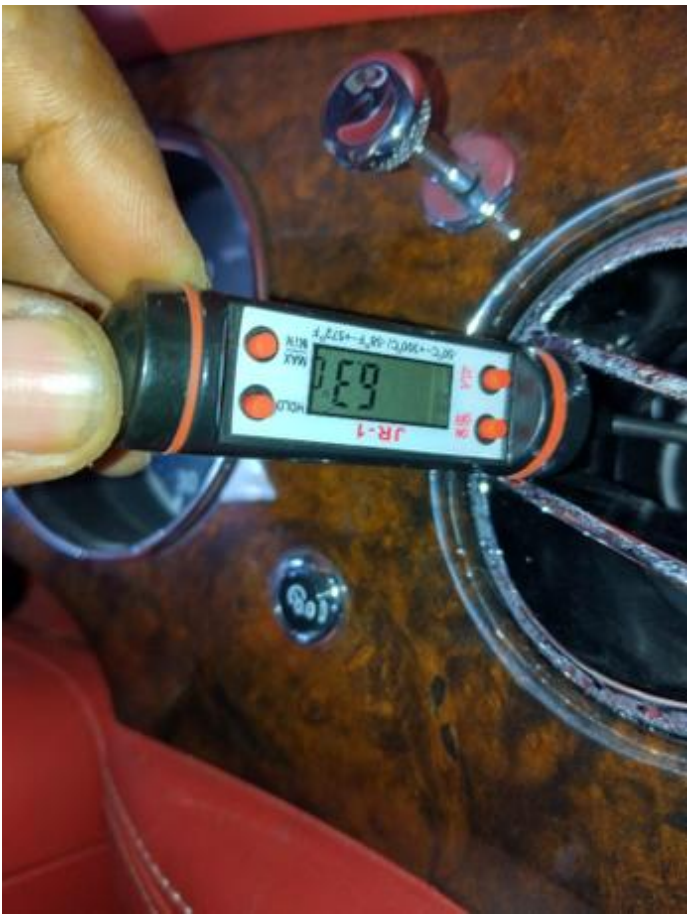
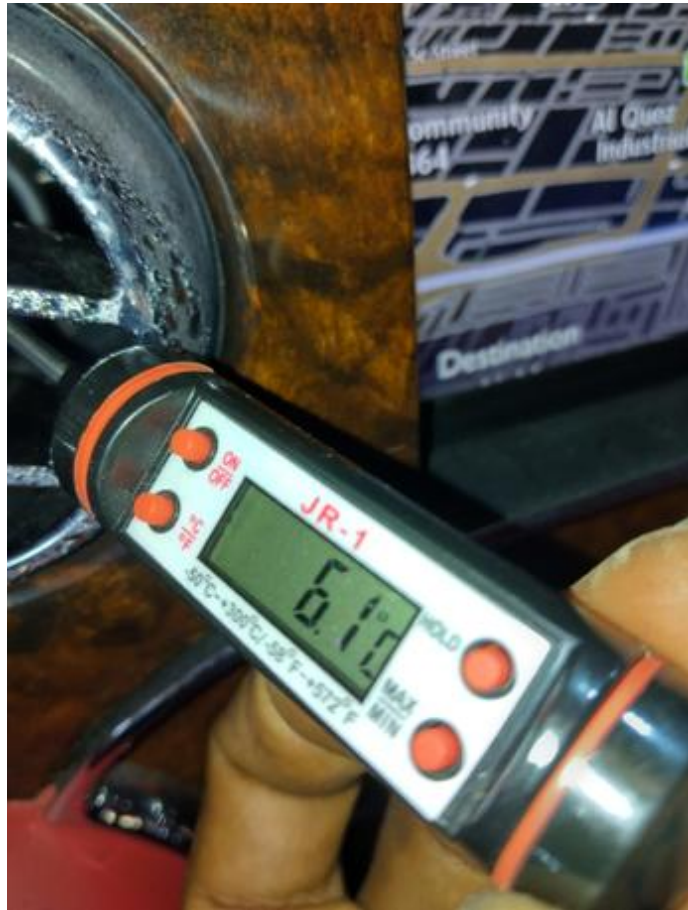
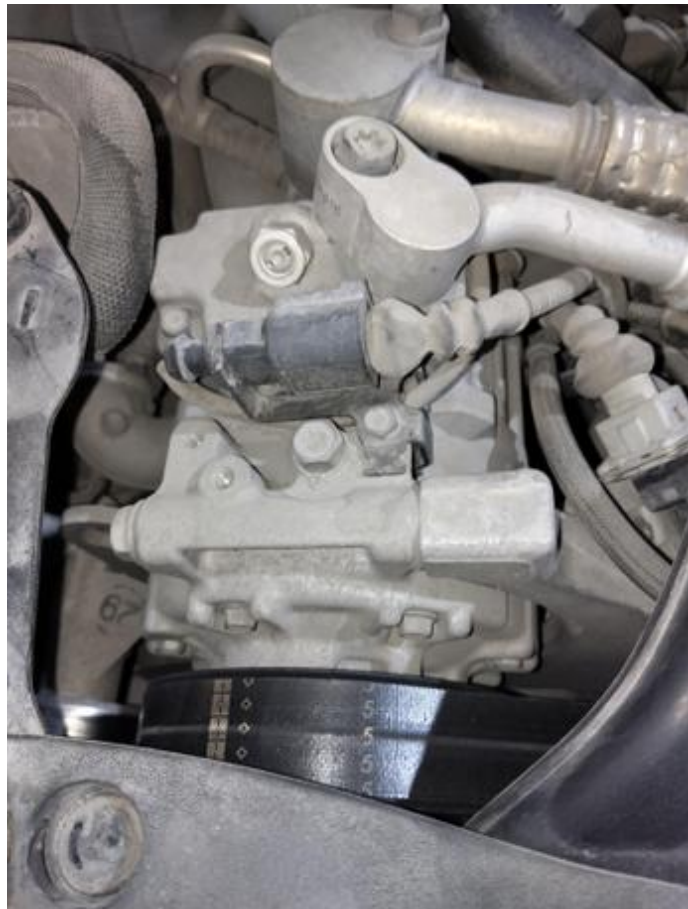
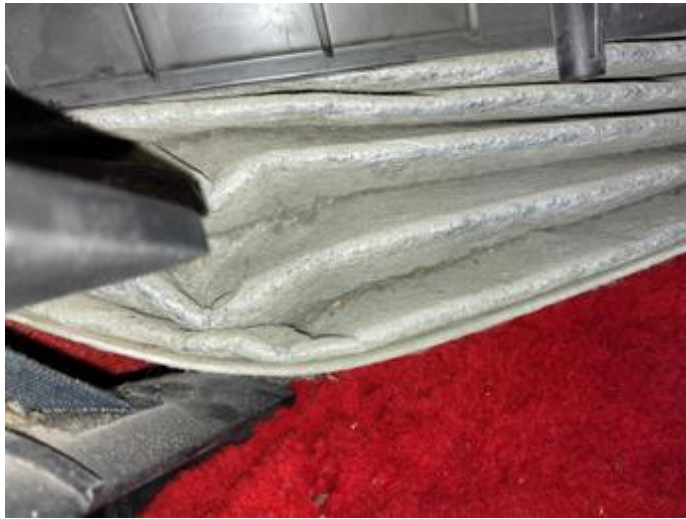
A/C System Faults & Condition (Max 4 Photos)

AC cooling is good

Cabin air filter need to replace. It is blocked

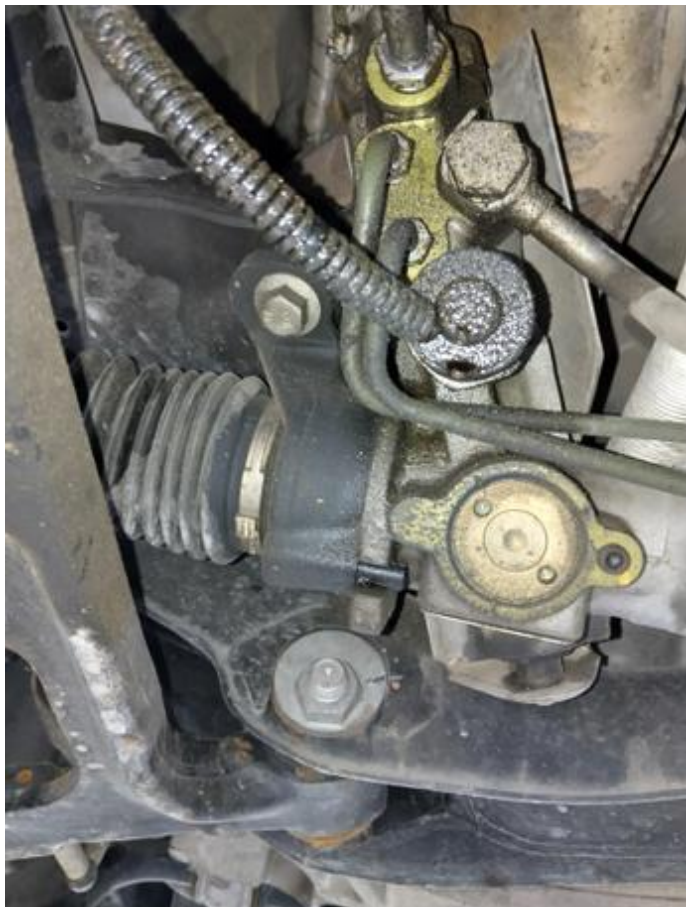
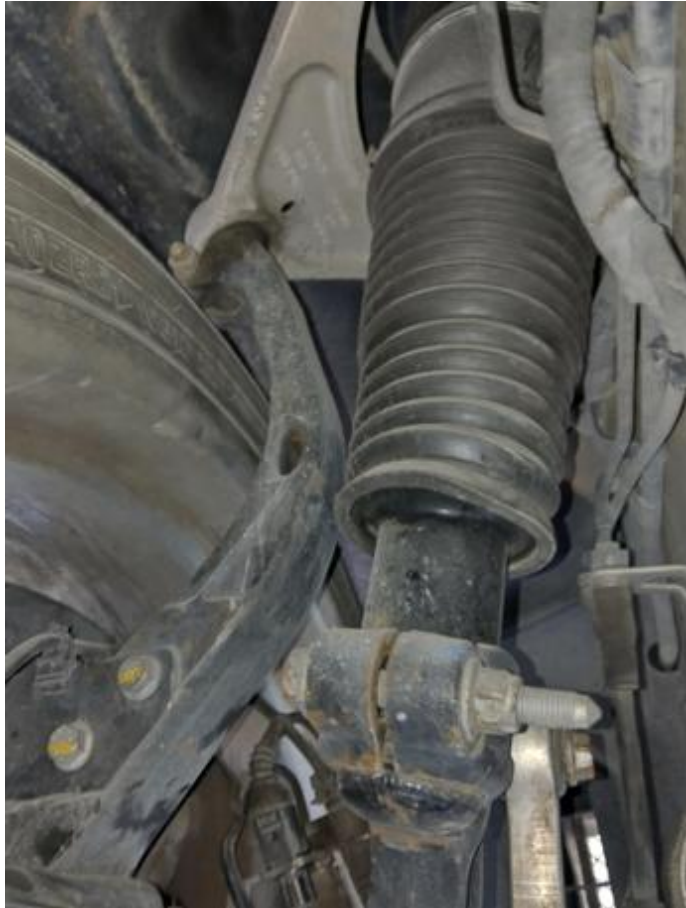
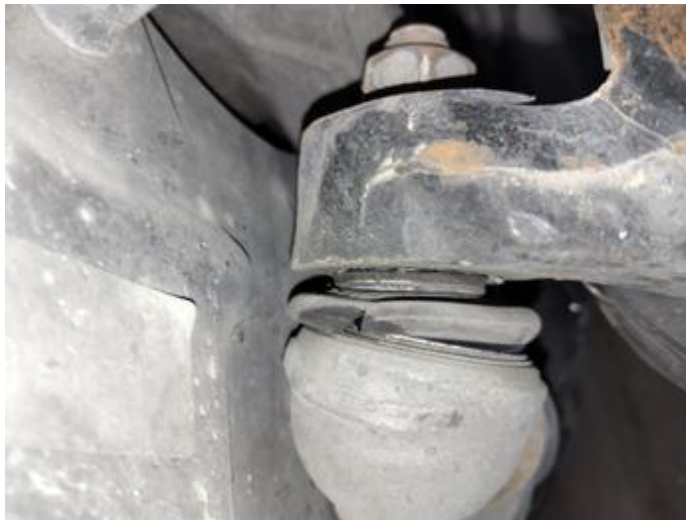
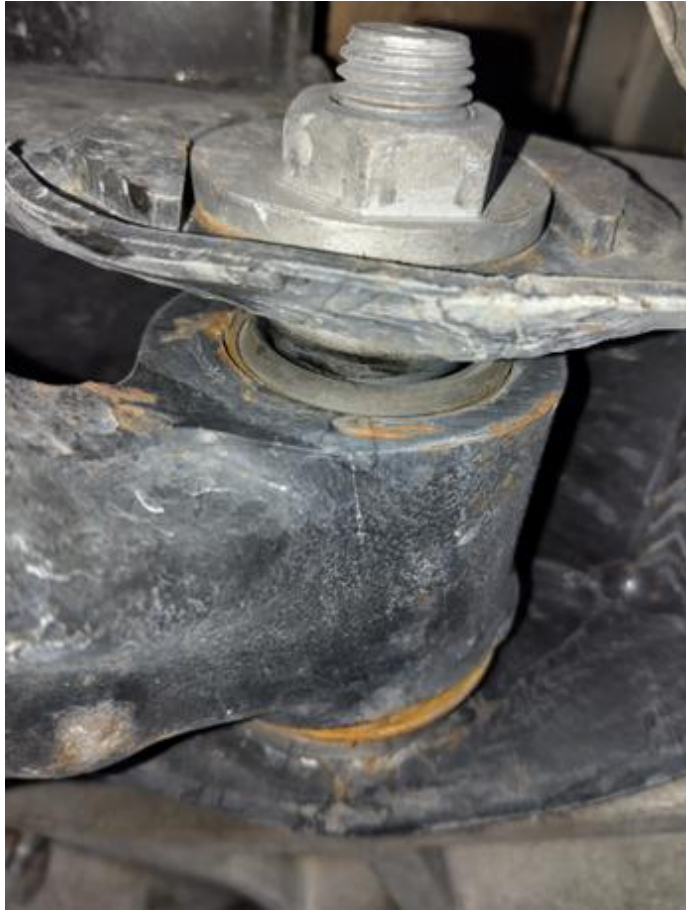
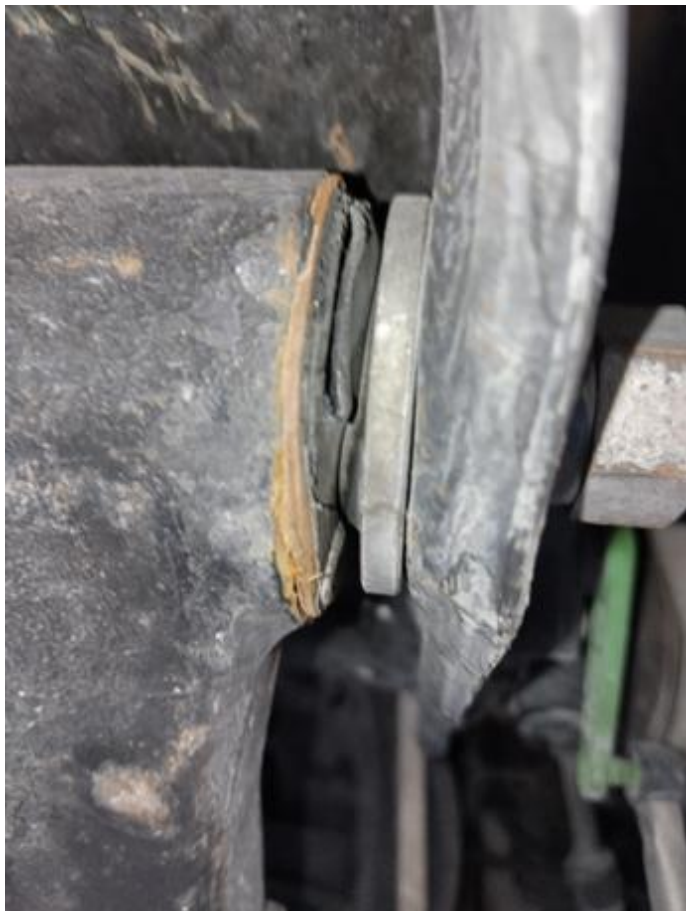
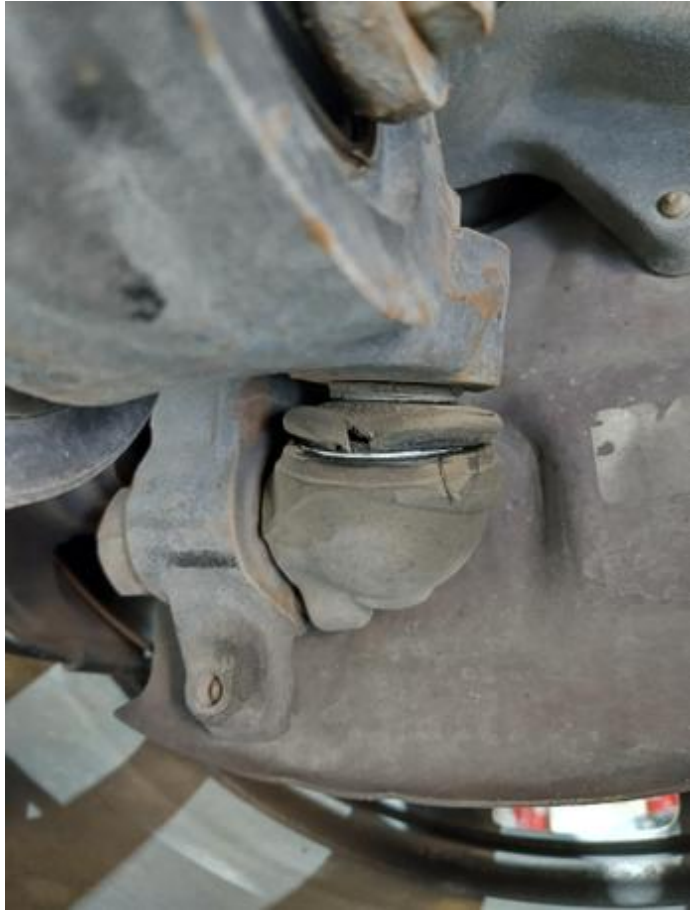
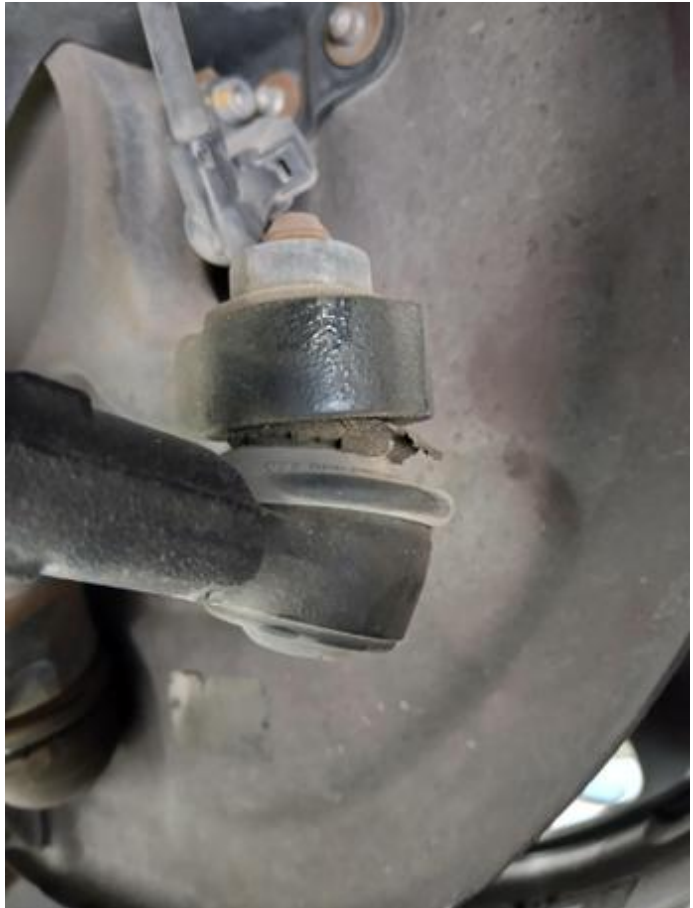
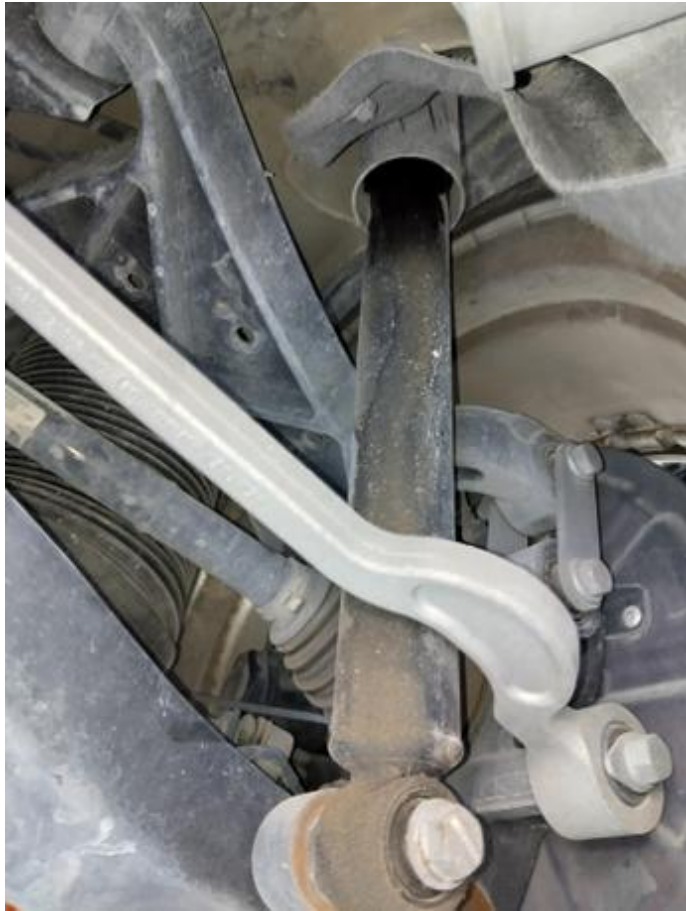
Suspension System Faults & Condition (Max 8 Photos)

Shock Absorber, Springs & Mounts	Requires IMMEDIATE attention
Control Arms, Sway Bar & Link Rods	Requires IMMEDIATE attention
Bushes & Bearings	May require attention SOON
Ball Joints	Requires IMMEDIATE attention

Rear shock absorbers is worn out - need to replace
Front lower arms assembly replace - bushes are cracked
Front upper arm assembly replace - bushes are cut
Front lower arms balljoints are defective both side

Under chassis
Front lower arms assembly
Front balljoint
Steering rack assembly
Steering coupling - has play
Front upper arm assembly 2pcs
Rear shock absorbers
