Warranty Multi-Point Vehicle Inspection

Date Monday, May 27, 2024

Vehicle Make & Model Bentley Mulsanne

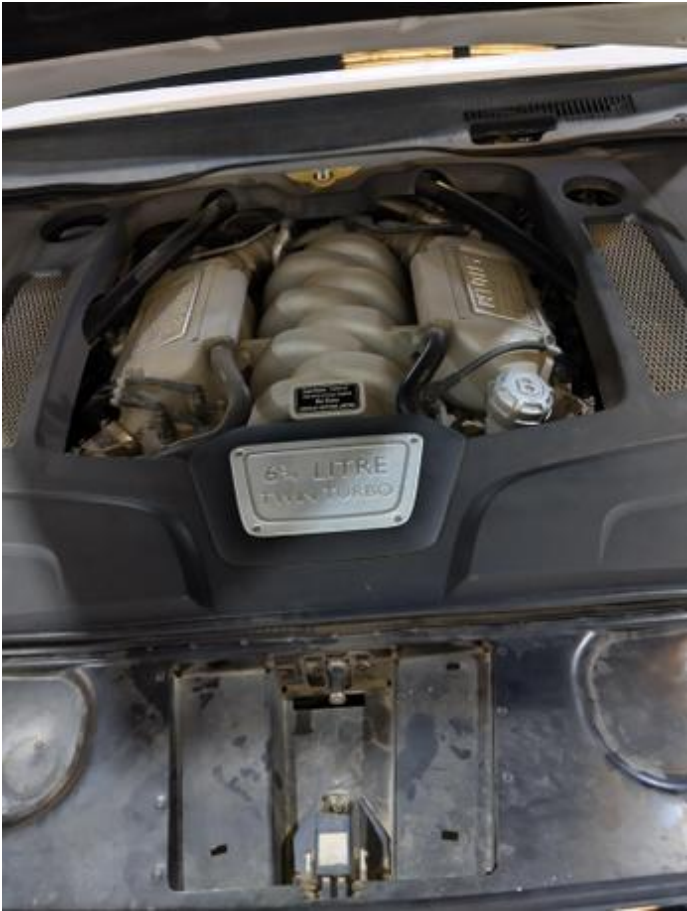
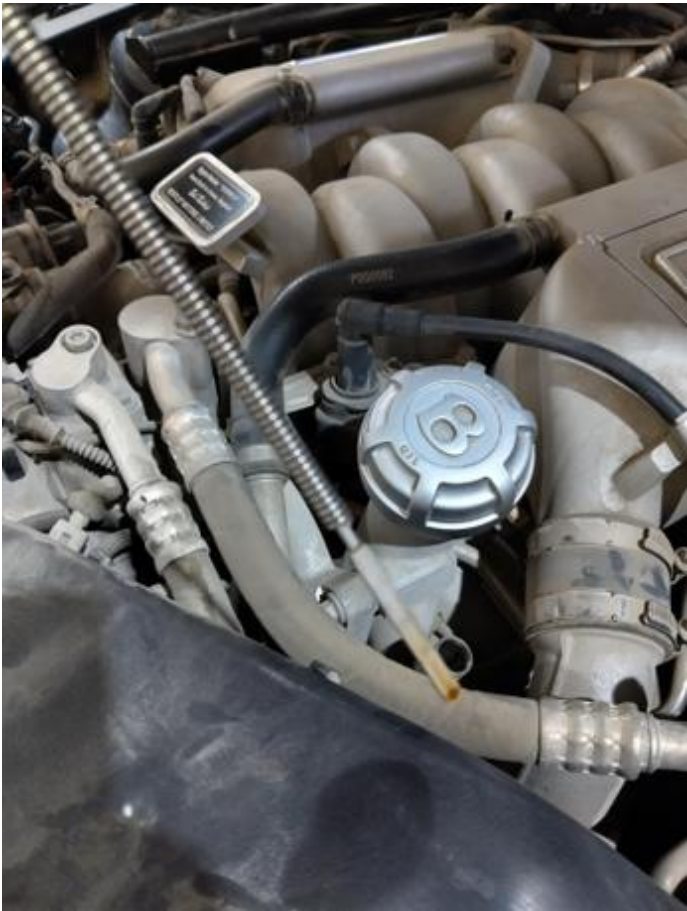
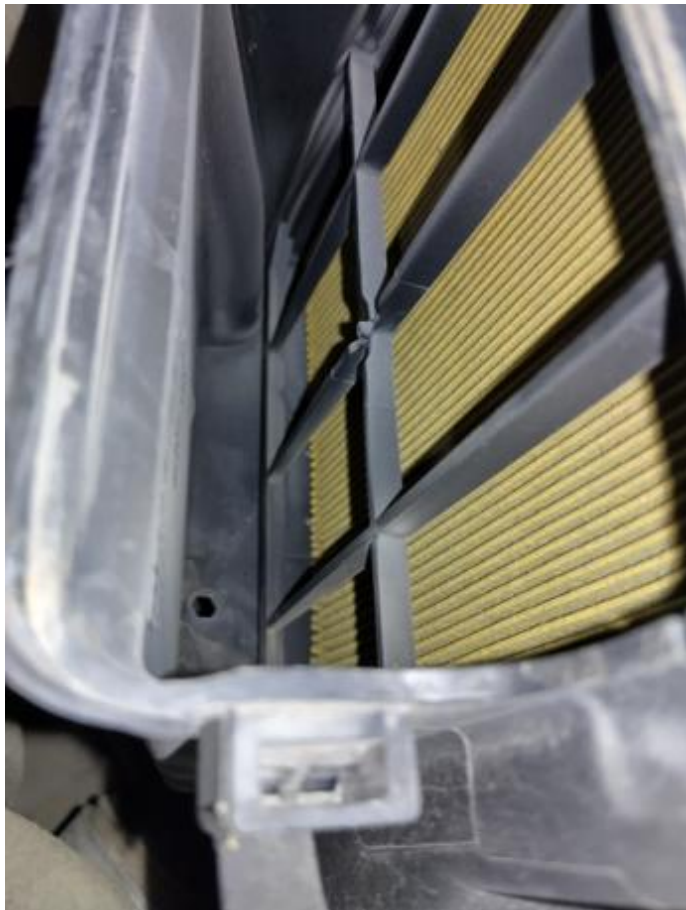
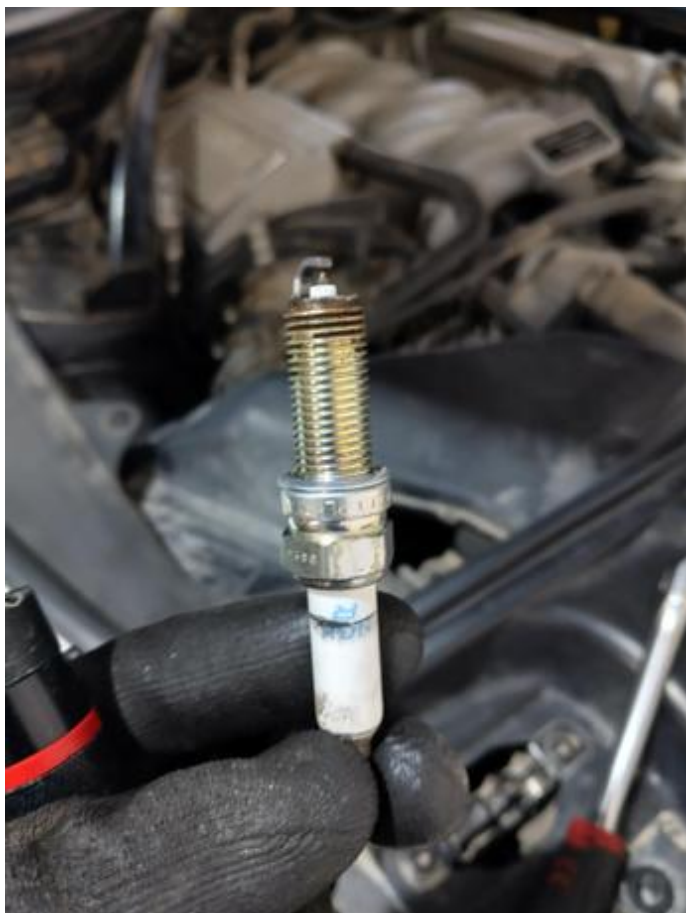
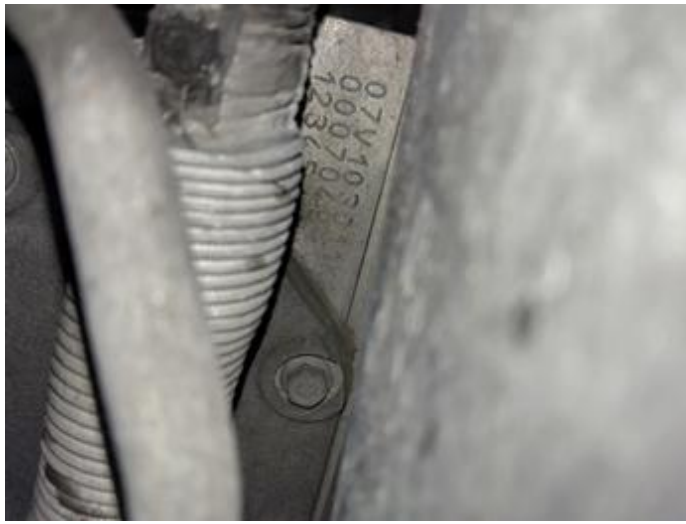
Powertrain System Faults & Condition
(Max 8 Photos)

Engine, Transmission, Drive Axle, Transfer Cases	Checked and OKAY
Belts: Engine, Accessory, Serpentine, and / or V-drive	Requires IMMEDIATE attention
Engine Cooling System & Hoses	Checked and OKAY
Engine Air Filter & Housing	Requires IMMEDIATE attention
Exhaust System Components	Checked and OKAY

Engine air filter need to replace
Engine drive belt need to replace
Drive belt tensioner and idle pulley need to replace

Engine
Engine drive belt
Engine air filter
Drive belt tensioner and idle pulleys
No service sticker found. Recommended to do service.
Cabin air filter
Transmission oil and filter
Rear differential seal
Rear differential oil

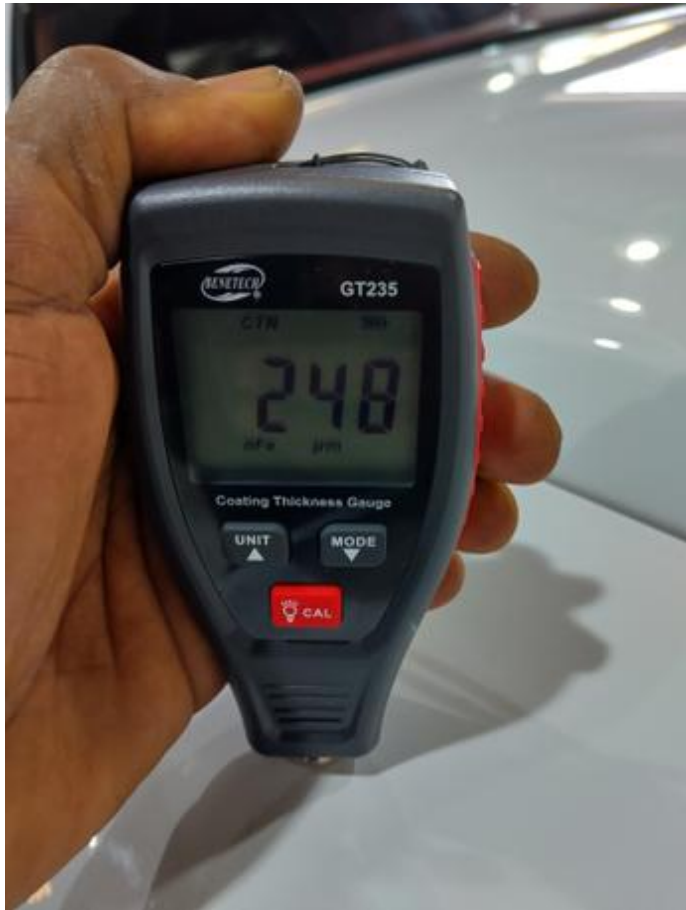
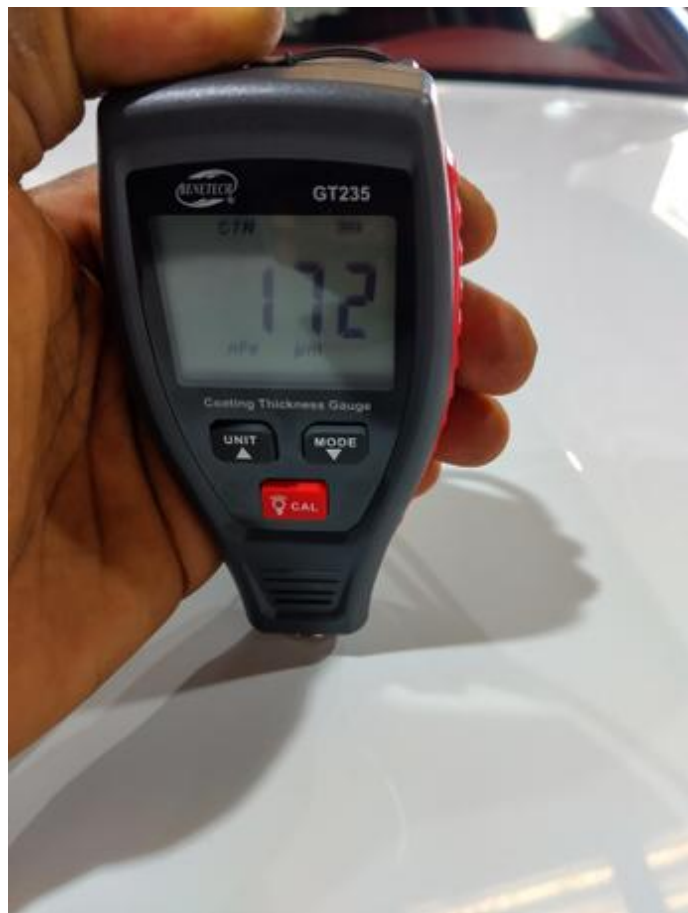
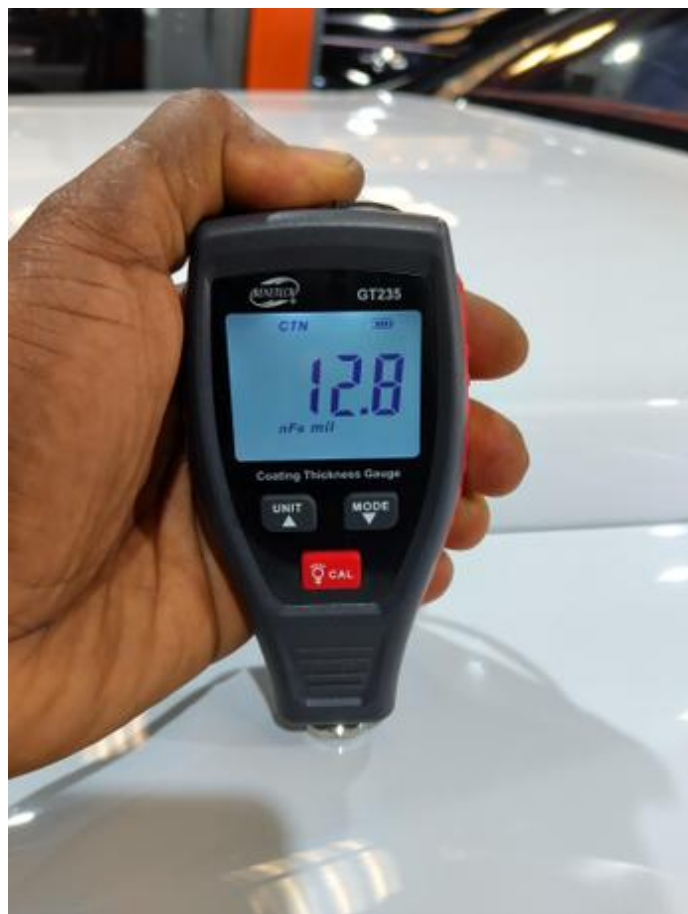
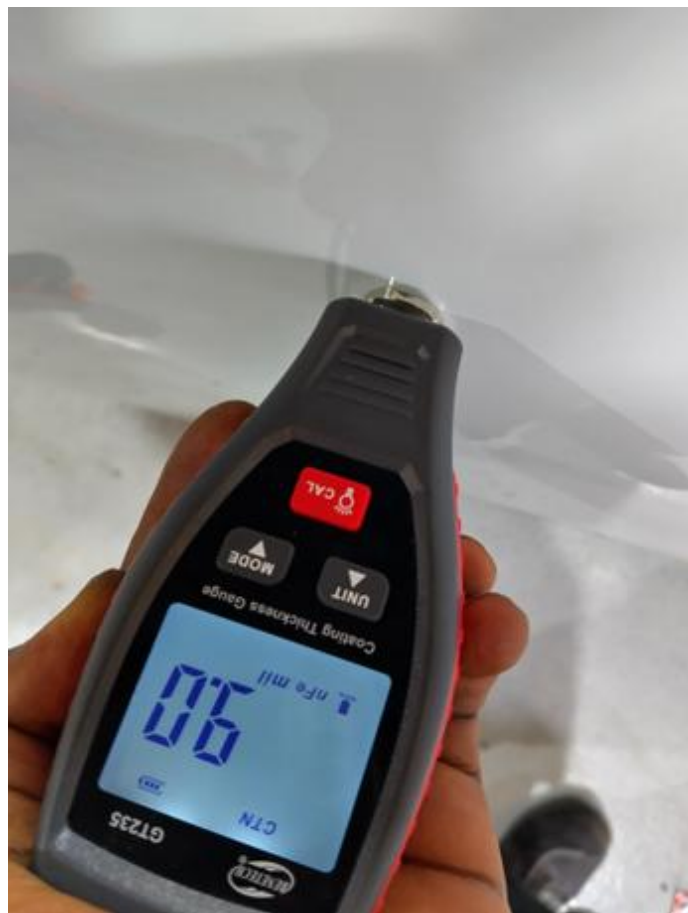
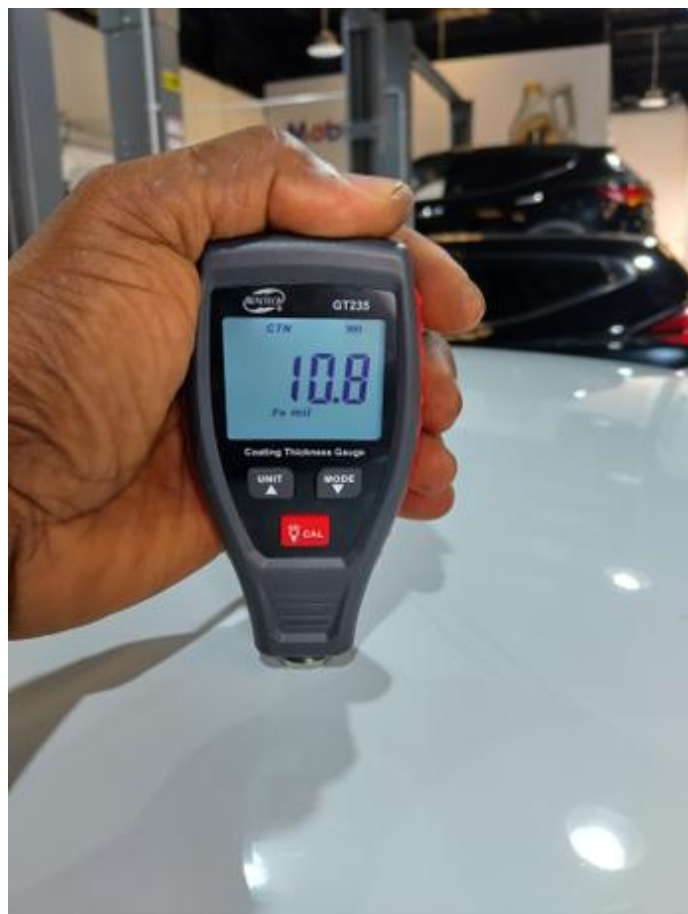
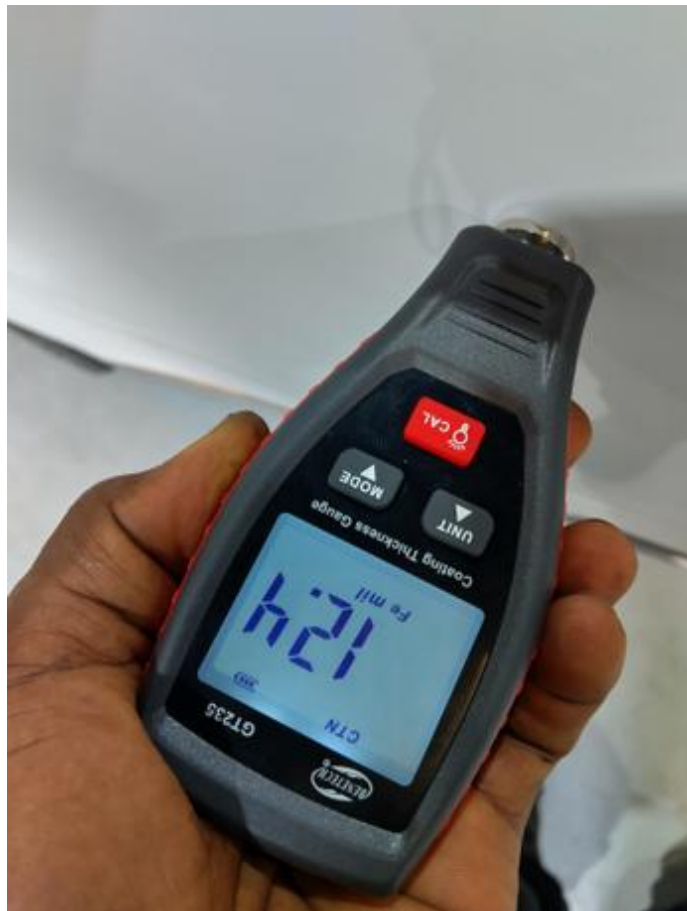
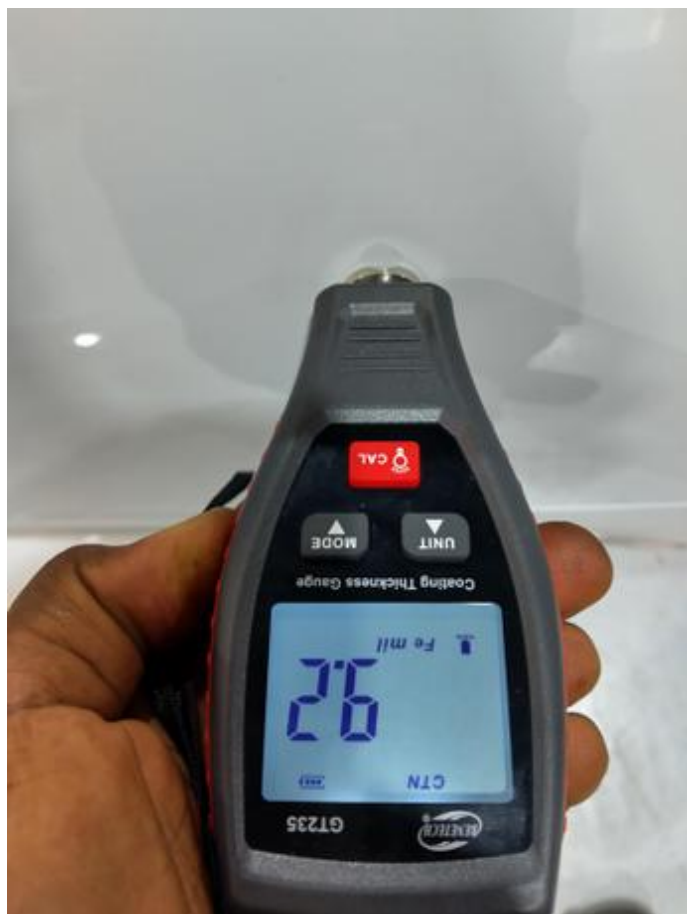
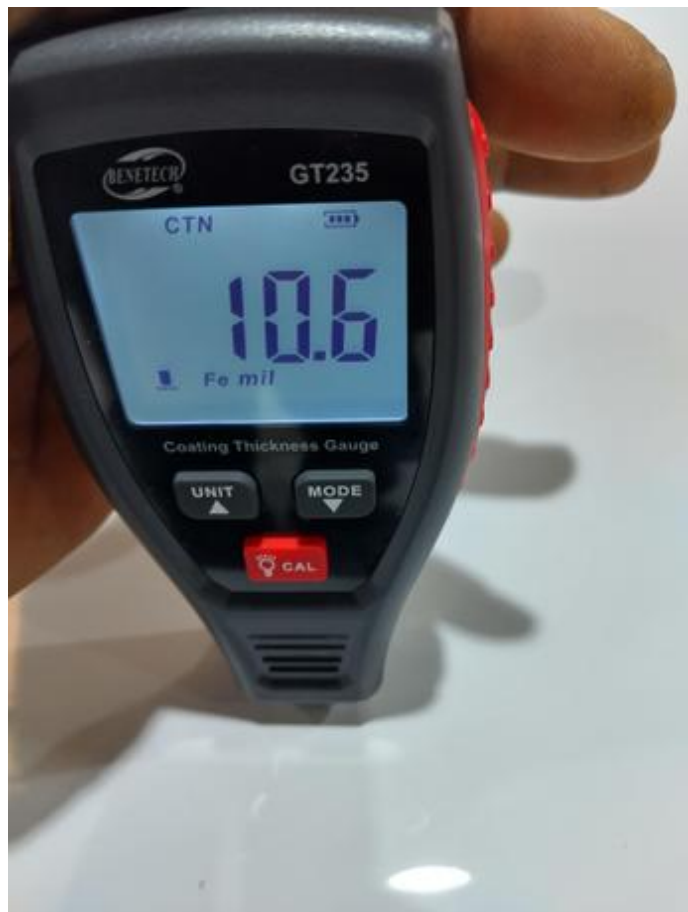
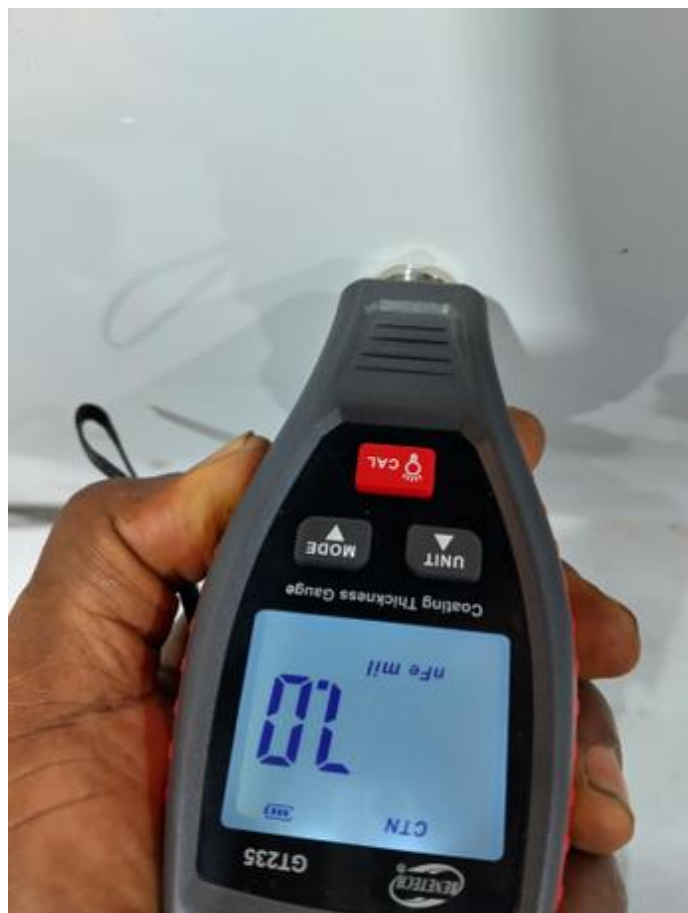
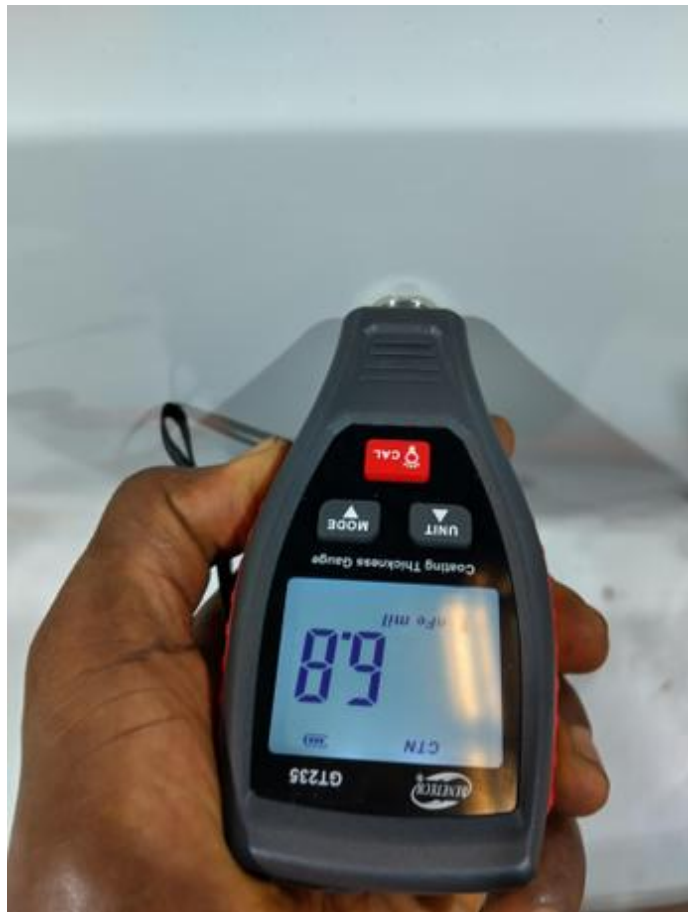
Paint & Body Faults & Condition (Max 16 Photos)

FR door paint is required > door handle side and mirror side is peeling
 Right side under chassis has been repaired and painted

Body
F.R door handle and side mirror painting required

NOTE:
FR under chassis repair has been detected

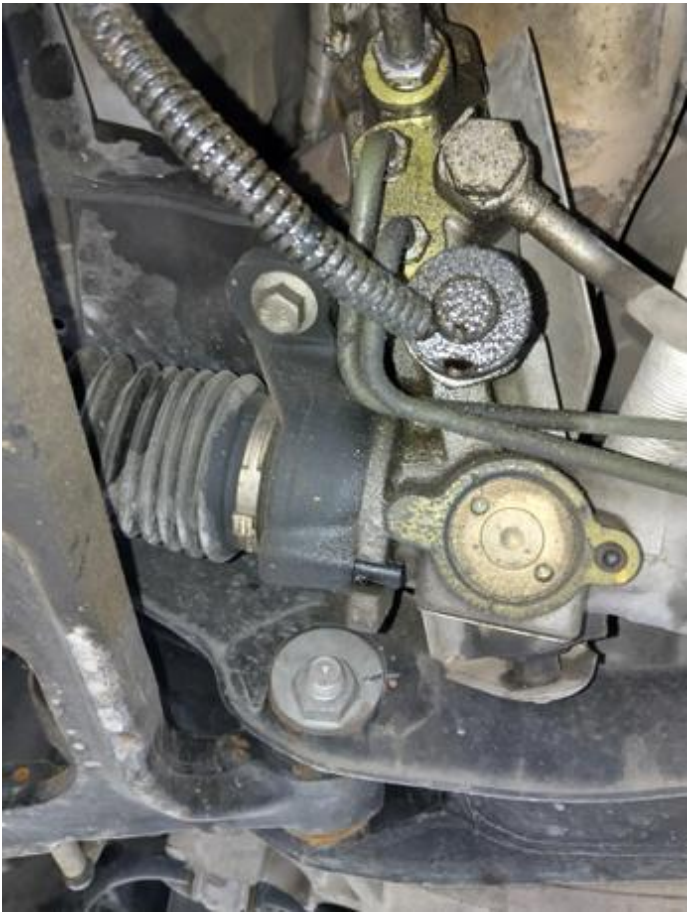
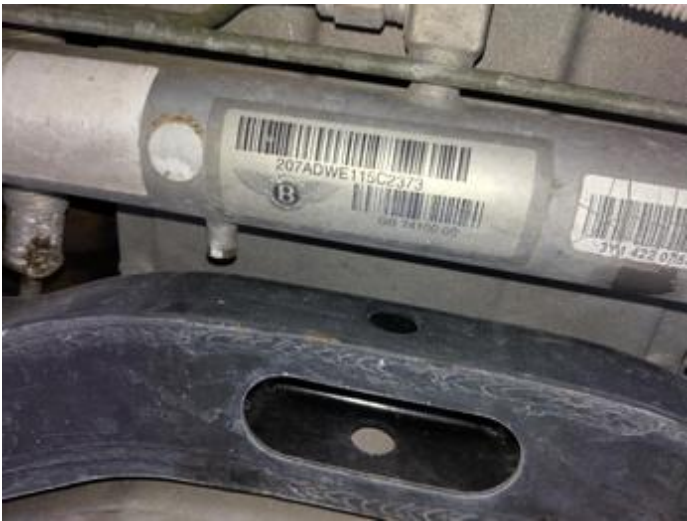
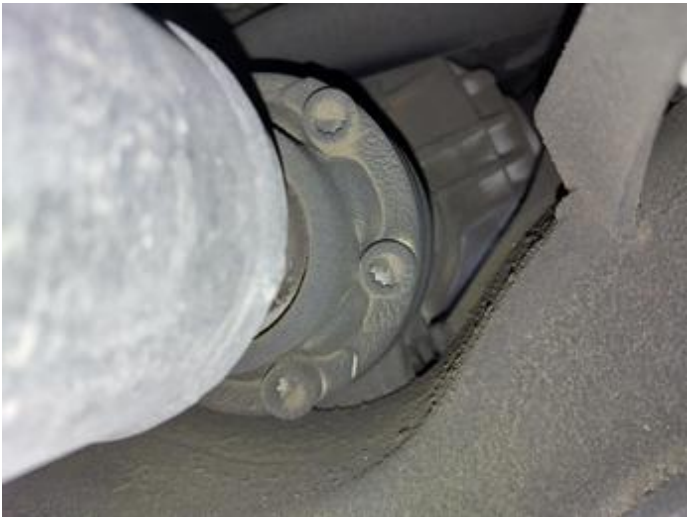
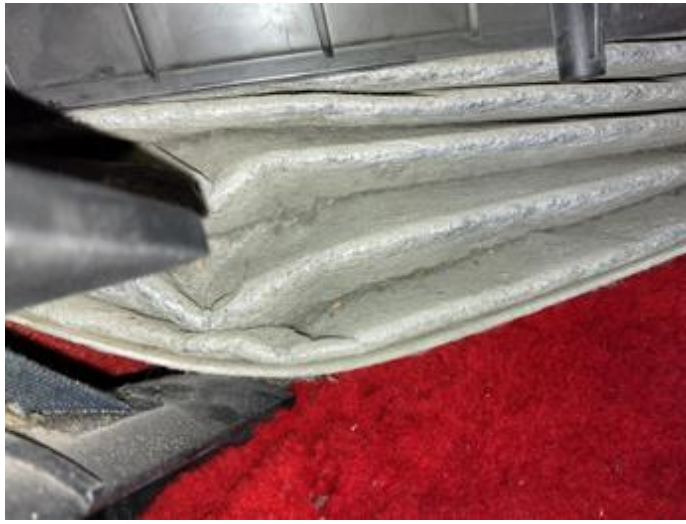
**Additional Checks Faults & Condition
(Max 8 Photos)**

Fuel System (includes gas cap seating)	Checked and OKAY
Hoses: Power Steering and HVAC	Checked and OKAY
Cabin Air Filter	Requires IMMEDIATE attention
Passenger Compartment Air Filter	Checked and OKAY
Steering Components and Steering Linkage	Requires IMMEDIATE attention
CV Drive Axle Boots or Driveshafts and U-joints	Checked and OKAY
Check Engine Light	Checked and OKAY
Body Components Lubrication	Checked and OKAY
Restraint System Component Check	Checked and OKAY
Chassis Components Lubrication	Checked and OKAY
Drive Axle (Leak / Other)	May require attention SOON
Radio & Infotainment System	Checked and OKAY

Under chassis
Front lower arms assembly
Front balljoint
Steering rack assembly
Steering coupling - has play
Front upper arm assembly 2pcs
Rear shock absorbers
